# Manhole Inspection Summary

Manhole # S31I2010MH

Insp Date: **12/21/06 9:28 AM**

**Location** Address: **10 GITTINGS AVE**

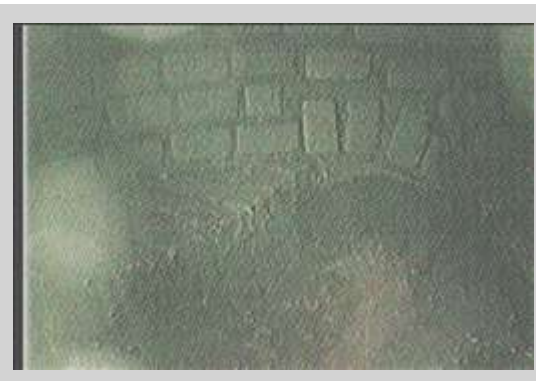
### Drop In @ 3 O'Clock

Drop: **Outside** Rod and Bar

Angled: **Yes** Reading: **13.26** (ft.)

Drop Condition: **Open**
